Name Of Dam: FALLING CREEK
Location: BEDFORD COUNTY
Inventory Number: 01910

PHASE I INSPECTION REPORT NATIONAL DAM SAFETY PROGRAM

PREPARED BY
NORFOLK DISTRICT CORPS OF ENGINEERS
803 FRONT STREET
NORFOLK, VIRGINIA 23510

SEPTEMBER 1979

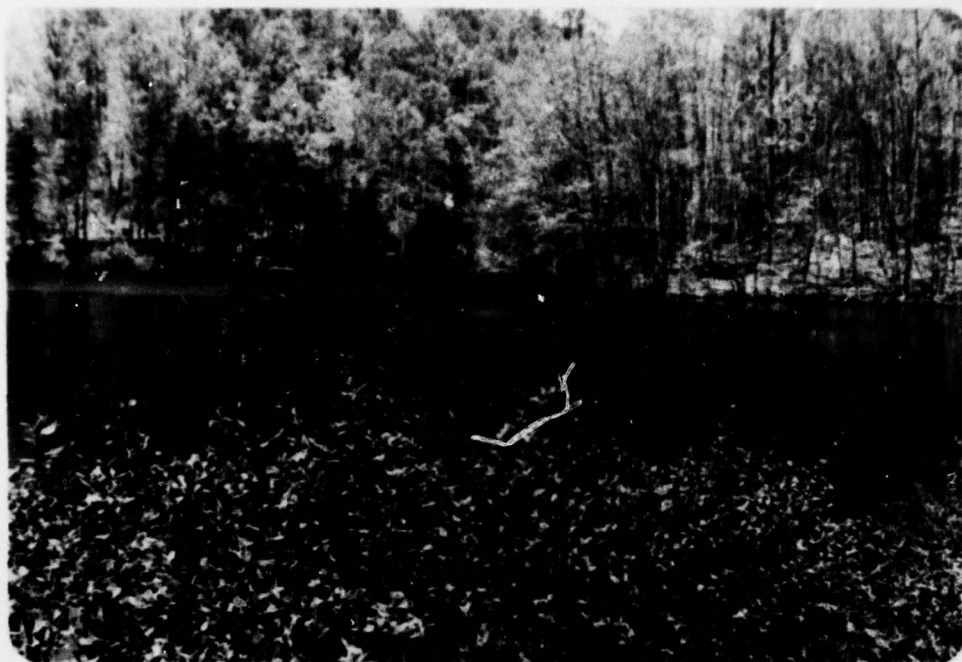
3.1.3 Appurtenant Structures: Observations of the intake structure were impossible, because it was submerged at the time of the inspection, Appendix II, Photo I. However, the 1972 diver's report (Appendix IV) notes some deterioration of the structure.

PHOTO #1 INTAKE STRUCTURE

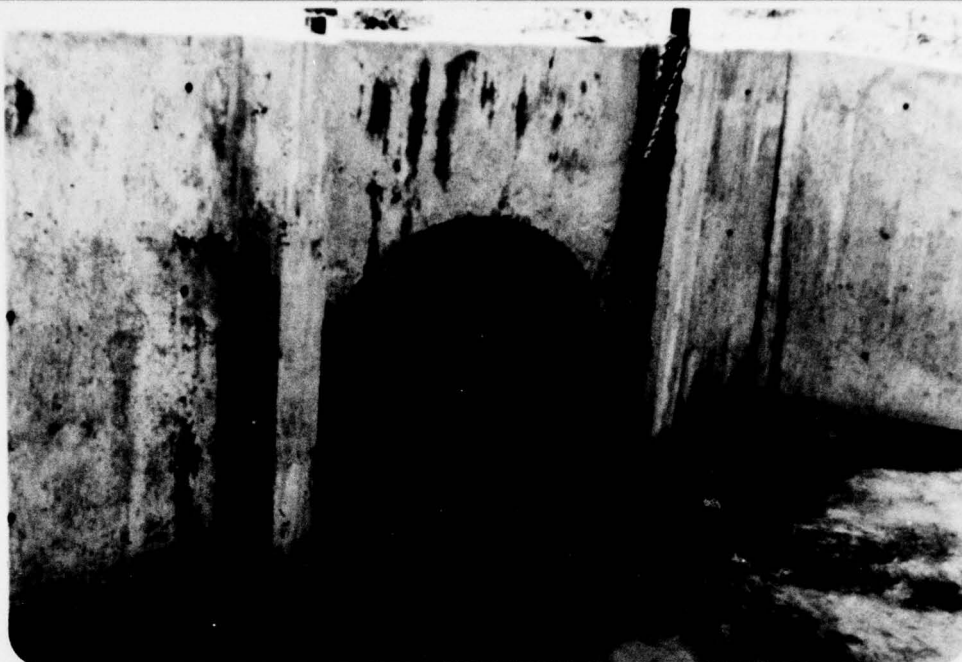
PHOTO #3 EMERGENCY SPILLWAY

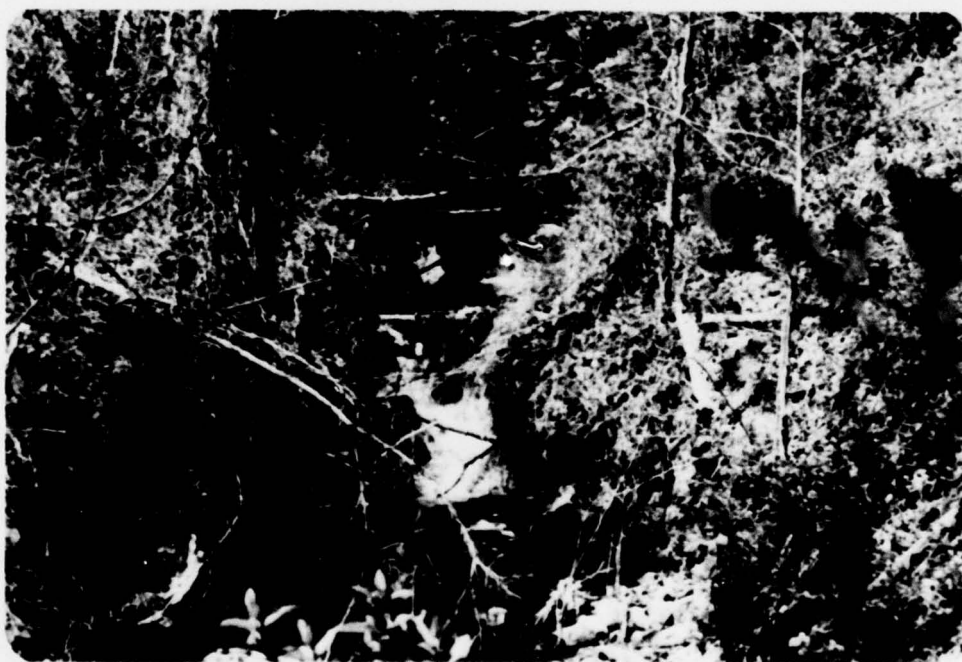
3.1.7 Downstream Channel: No erosion was observed in the downstream area. However, the channel is overgrown with trees and shrubs, Appendix II, Photo 4. The filtration plant is immediately downstream. About 6 to 7 homes and stores are located along Route 635 at the Route 24 intersection, 1.5 miles downstream.

PHOTO #4 EMERGENCY SPILLWAY
DISCHARGE CHANNEL

VISUAL EXAMINATION OF	OBSERVATIONS	REMARKS OR RECOMMENDATIONS
CONDITION (OBSTRUCTIONS, DEBRIS, ETC.)	The channel below the spillway is 8-10 feet wide and 6-8 feet deep with rocks and some tree limbs in the immediate vicinity. The seeps at the toe of the dam keep the area wet with a small channel to pass the flow into the main channel that enters from the right side of the dam.	None.
SLOPES	The right slope is steep and wooded. The left slope is mild to steep with the road, filtration plant, and other small buildings in the immediate (mild) area.	None.
APPROXIMATE NO.	The filtration plant is immediately downstream. About 6 to 7 homes and stores are located along Route 635 at the Route 24 intersection 1.5 miles downstream.	None.

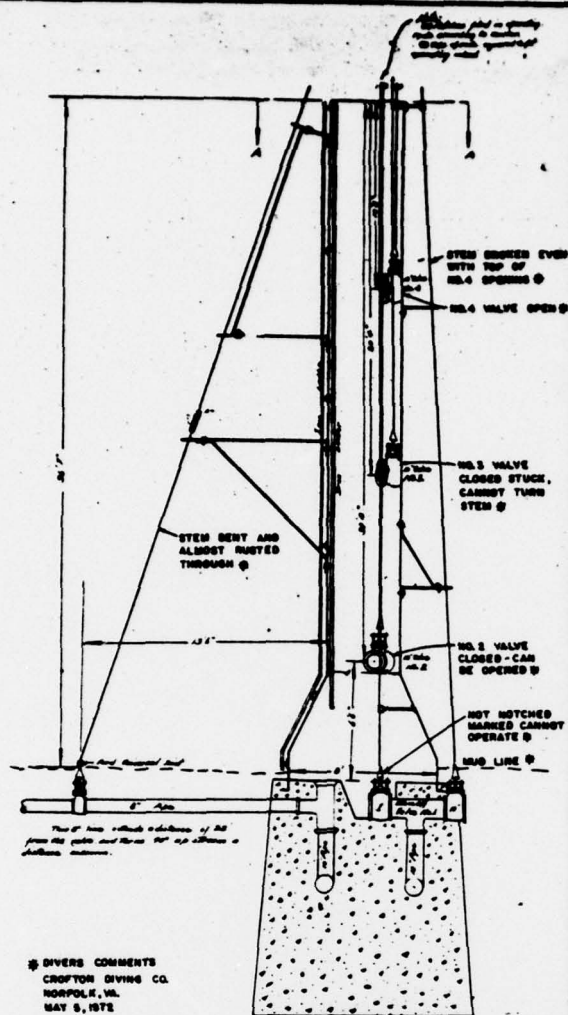
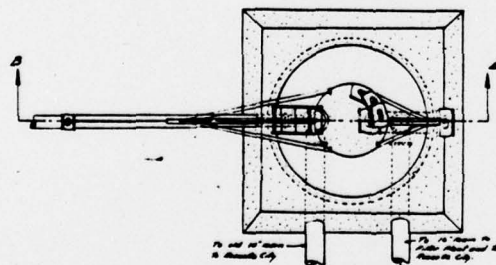
STACK
AT FALLING CREEK RESERVOIR, BEDFORD COUNTY, VIRGINIA.
FROM DATA AVAILABLE AFTER COMPLETION OF WORK OF THE DEEP SEA DIVER.
REANNE WATER WORKS COMPANY - REANNE, VIRGINIA, OCTOBER 2, 1961.
DRAWN & TRACED BY - H. H. HARRIS, DRAFTSMAN.

c. A 1972 diver's inspection report of the intake structure with all comments noted on the drawing in Appendix IV.

VISUAL EXAMINATION OF	OBSERVATIONS	REMARKS OR RECOMMENDATIONS
CRACKING AND SPALLING OF CONCRETE SURFACES IN OUTLET CONDUIT	N/A	
INTAKE STRUCTURE	<p>The intake "stack" structure is submerged. It has three intake levels. The top level has an open 10-inch valve. The bottom two are closed. An outlet pipe passes through the dam and ties into a 16-inch pipe which leads to the filtration plant. The line has a blowoff valve that discharges into the downstream channel when opened.</p>	<p>The divers report explains the condition of all valves and stems on the stack.</p>
OUTLET STRUCTURE	<p>Two 12-inch blowoff valves located below the toe of the dam may be operated to draw water from the reservoir while the lines serve water to the filtration plant.</p>	<p>Valves have not been operated.</p>
OUTLET CHANNEL	<p>No formed channel is apparent, but a flat wet area does pass some flow which originates from the four seep areas.</p>	<p>None.</p>
